Saxmundham Town Council

- a) To consider the ongoing management and operation of the Adventure Playground.
- b) To receive the quarterly play equipment inspection reports dated February 2025 from East Suffolk Council and consider any necessary action.

Chantry Road

Routine/Visual Inspection 13-February-2025 - 08:45 by Gary Vann

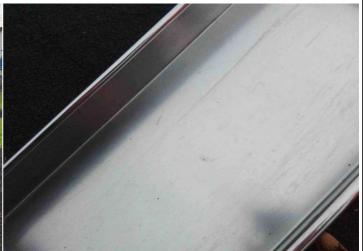
Activity Equipment - Multi Play (Junior) Manufacturer:

Finding: There are a number of dents in the slide surface

Action: Monitor for any further deterioration and repair as required

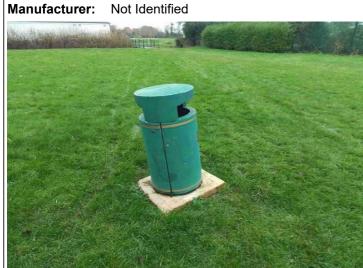
Item: Ancillary Items - Litter Bin

Finding: The item has been damaged

Action: Monitor for any further deterioration and replace as required

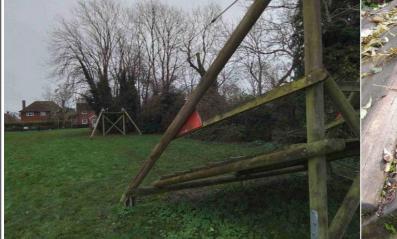
Item:Other - Cable RunwayRisk Level:L - Low RiskManufacturer:Eibe Play LtdSurface:Grass Matrix Tiles

Finding: There are areas or parts of the timber on the structure that have rotted

Action: Replace all affected timbers

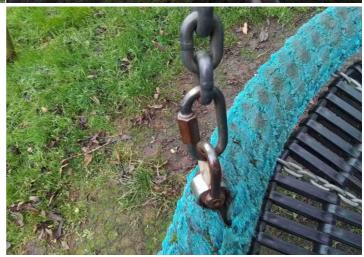
Item: Swings - Basket Swing - Type 1

Finding: There is some wear to the shackles.

Action: Monitor for any further deterioration and replace when 40% worn
