Saxmundham Town Council

Members of the Amenities and Services Committee are summoned to attend a meeting on Thursday 20th November 2025 at 5:30 pm at the Town House, Station Approach, Saxmundham

Safety Inspection Report

Site name: **Seaman Avenue Play Area**
Date of inspection: **25 September 2025**
Inspector: **David Owen**

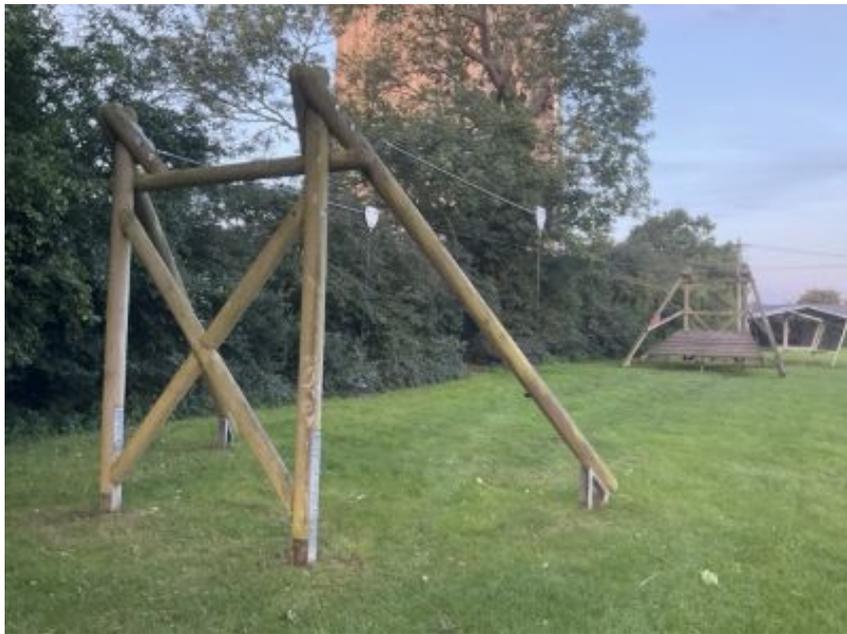
Cableway - Double Track

1. Chains links worn.
2. Item has some parts missing.
3. Surface has unintended weeds.
4. Timber is decayed.

Seat chain links wearing.

Traveller guard missing.

Ramp slats are decaying and splintering.

Replace the worn parts.

Replace the missing parts.

Replace affected parts.

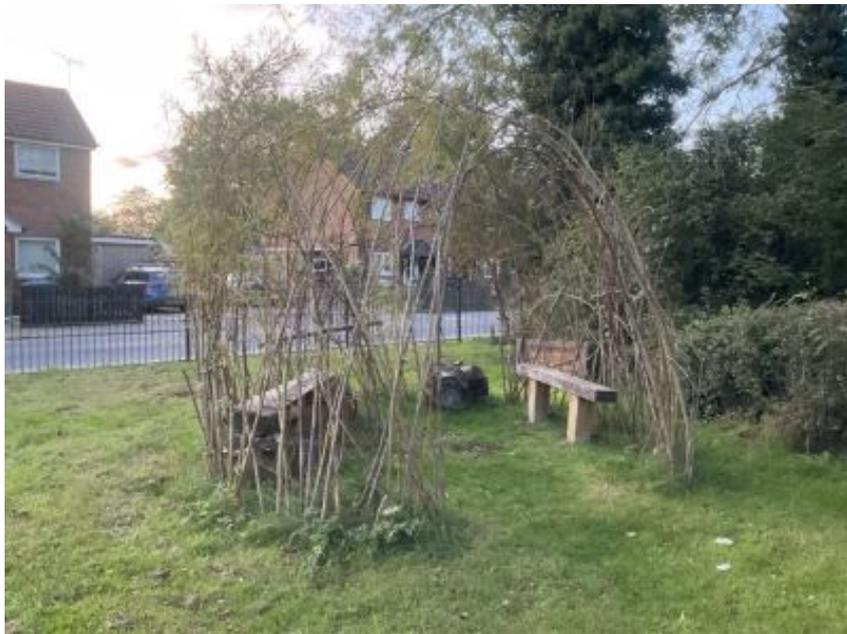
Natural Play - Willow & Seating

Bench within the willow den is loose in the ground.

The log bench has fungus growth. Remove and monitor for decay.

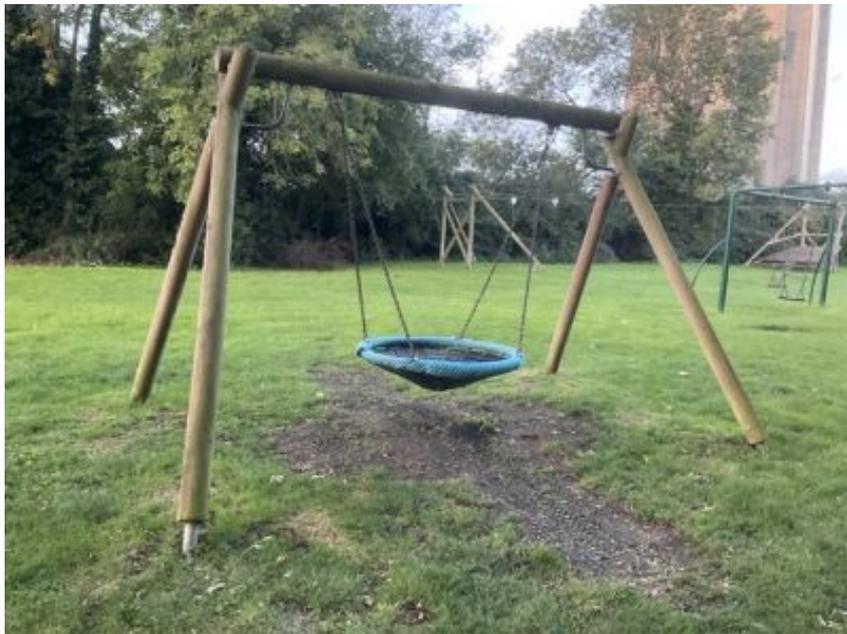
Swing - Nest

Seat chain bushes are worn and one missing. Replace x 4.

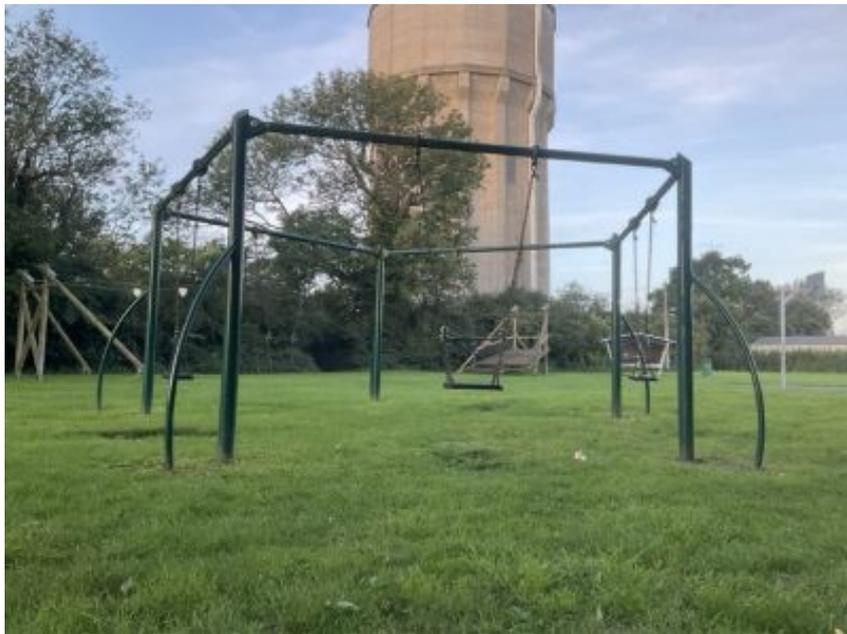
Swing - Contact - Junior - Pentagon

One seat connector bent. Repair.

Cap missing.

Replace.

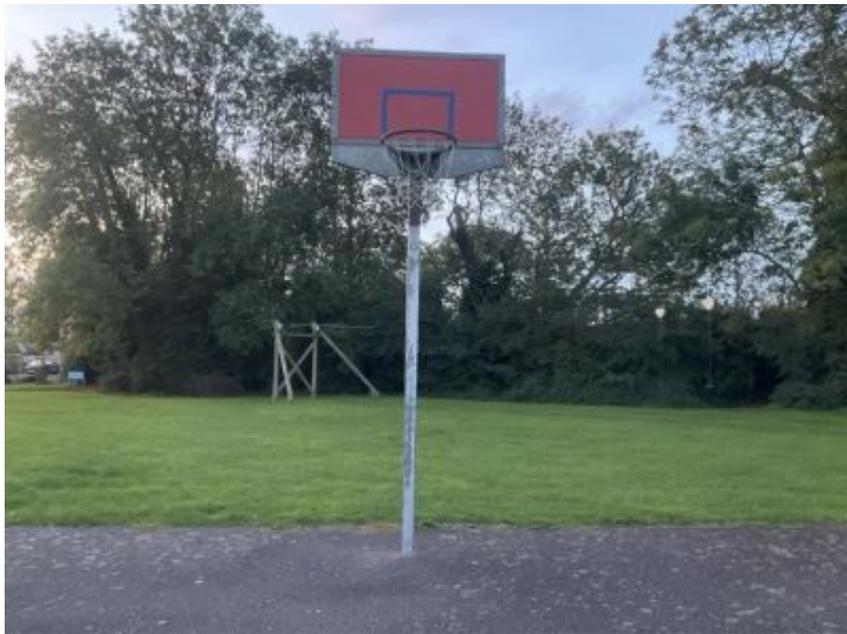
Basketball Post

1. A clearly visible sign must be fitted to all sports related equipment with at least the following: a) equipment is not intended for children less than 36 month, b) "Do not climb on the framework or nets", c) "Do not hang on the ring", d) "Do not wear rings or other jewellery as these can get caught and cause injury", e) name and telephone number of site owner, f) number to call in case of accident.

Fit warning notice.

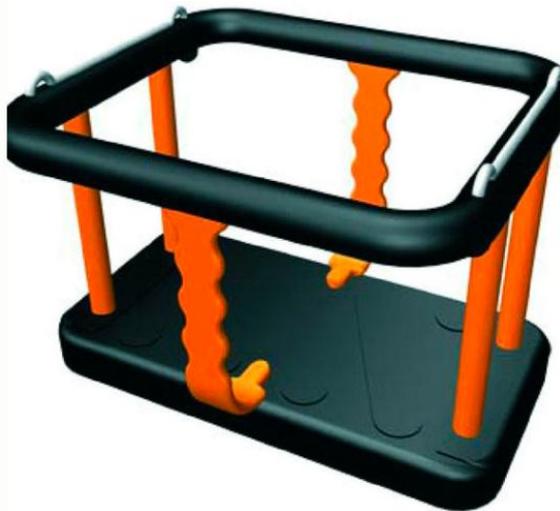
Sutcliffe Cradle Seat In Black And Orange Rubber

This model is by a different design company, Sutcliffe. The Maintenance Officer contacted this manufacturer to confirm various aspects of the design –

- 1) The pillars thread into the upper ring and are bolted to the seat (7,8).
- 2) The front and back guards bolt both top and bottom (11,12), unlike the previous design which only holds those to the top ring with the moulding just pulling into the seat.
- 3) The chain is held by separate system as well.

Designs 2 and 3 represent structurally improved options, so it is recommended that the Committee considers either of these to replace the Chantry Rd swing seat.

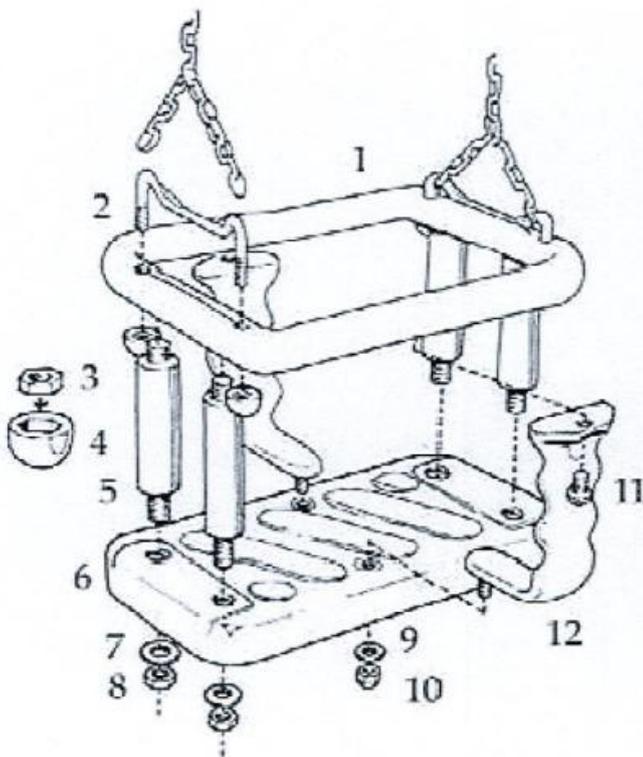
Cradle Seat Spares

- 1 SRE510 Top Ring (each)
- 2 ASS176 U Bolt (each)
- 3 LKN314 M8 Binx Nut (each)
- 4 FIX208 U Bolt Plastic Cap (each)
- 5 SRE525 Pillar Assembly (each)
- 6 SRH125 Seat Base (each)
- 7 WSR040 M10 Plain Washer (each)
- 8 LKN320 M10 Nyloc Nut (each)
- 9 WSR030 M8 Plain Washer (each)
- 10 LKN312 M8 Nyloc Domed Nut (each)
- 11 MCS209 M8 x 12 Skt Button Head Screw (each)
- 12 SRE530 Centre Crutch Support (each)

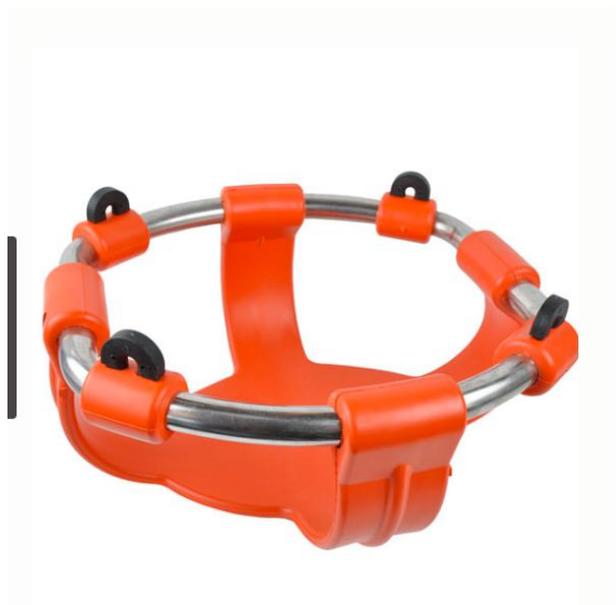
Sutcliffe Pod Toddler Cradle Seat

This design is also available and offers an alternative option, which overcomes the issues encountered with the current design and provides a different style at the Chantry Rd Playpark.

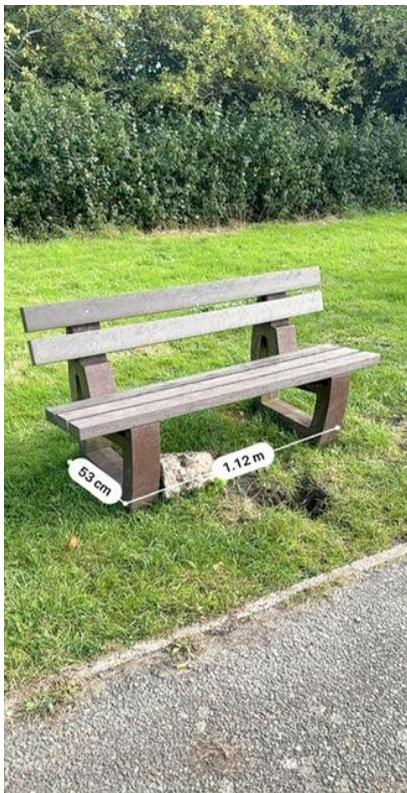
One of the benches at the Memorial Field has been lifted out of the ground and needs to be resecured.

To dig out the area 1500 mm x 650 mm x 150mm deep, place shuttering and concrete, leave to set and then install the bench leaving the area tidy.
